# Manhole Inspection Summary

Manhole # S21KK\_035MH

Insp Date: **6/1/07 8:27 AM**

**Location** Address: **2100 FULTON AVE**

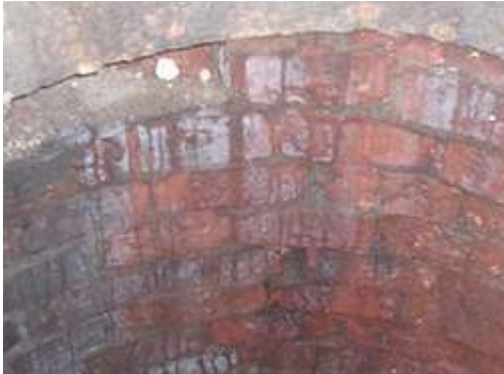
Defect 3

Condition: ☐ Sound ☐ Cracked ☐ Root Intrusion ☐ Loose Brick ☒ **Deteriorated**

Infiltration: ☐ None ☐ Joint ☐ Cracks ☐ Mortar ☐ Roots ☒ **Wall**

INFILTRASTION OF CORBEL AND  
DETERIORATED

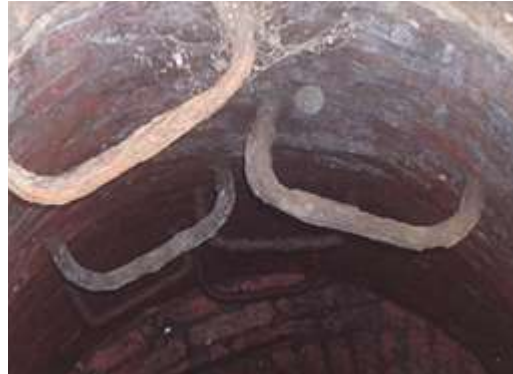
Defect 2

**Steps** Count: **4** Missing: **0** ☒ **Corroded**

CORRODED STEPS

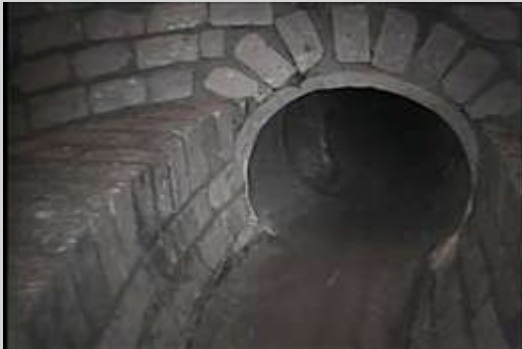
12 O'Clock Outflow

15 in. Circular Gravity Sewer  
Pipe Out @ 12 O'Clock

Pipe Height: **15.6** (in.) Rod and Bar (Angled)  
Pipe Material: **Clay** ☐ Pipe Lined  
Invert Depth: **10.25** (ft.) Flow Characteristics: **Slow**  
Deposits: ☒ None ☐ Mud ☐ Sludge ☐ Debris ☐ Grease  
Silt Depth: (in.) Deposits Extent:  
Infiltration: **None** Pipe Seal Cond: **Sound**

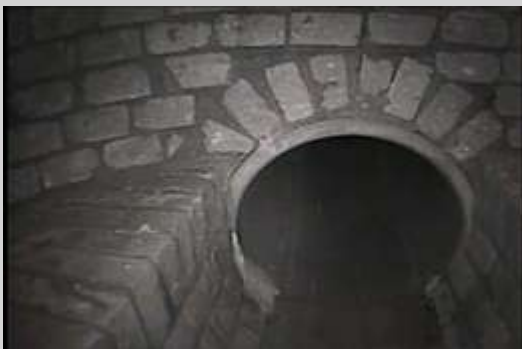
5 O'Clock Inflow

15 in. Circular Gravity Sewer  
Pipe In @ 5 O'Clock

Pipe Height: **15.6** (in.) Rod and Bar (Angled)  
Pipe Material: **Clay** ☐ Pipe Lined  
Invert Depth: **10.17** (ft.) Flow Characteristics: **Slow**  
Deposits: ☒ None ☐ Mud ☐ Sludge ☐ Debris ☐ Grease  
Silt Depth: (in.) Deposits Extent:  
Infiltration: **None** Pipe Seal Cond: **Sound**
